Exploring the Feasibility of Solid-Fuel Use in a Turbojet Engine for Reduction of Mechanical Complexity

Science Leadership Academy Engineering

Prototype 1: Deoxygenated Compressor Start-up

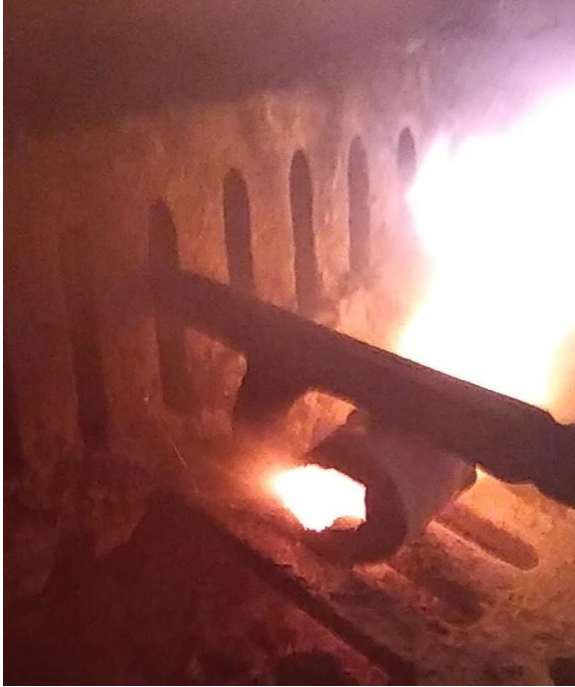
Figure 3.

Photograph of fuel grain combustion during airflow.

The first fuel grain to be made during this experiment, which was meant to be a test of the “1:1, no airflow” variable, had a chunky texture due to a low heating temperature. This would later prove to have a large effect on the burn rate. When the fuel grain made for variable “1:1, airflow,” was tested, there seemed to be a clear response to the increased airflow (see fig. 2

and fig. 3), but when the burn rate was calculated, it was found to be comparable to the “no airflow” test, disagreeing with the hypothesis. Believing there to be a mistake in the results, a new fuel grain was made for the “1:1, no airflow” variable, this time ensuring that the fuel mixture had been completely melted down and was no longer lumpy. This time, the burn rate was substantially lower, possibly indicating that fuel with unmelted particles has a higher burn rate because more surface area is available for combustion. It is important to note that airflow was not sustained for the entire duration of the airflow tests because the experimenter had to inhale. On the second day of the experiment, when both 1:2 variables were scheduled to be tested, it was decided that the tests would be done indoors due to inclement weather. First, was the 1:2, no airflow test, which took an astounding 61 seconds to burn and extinguish itself, indicating an extremely low burn rate. When calculated, the 0.037 g/s burn rate was approximately 5 times lower than the 1:1, no airflow test, showing that the amount of oxidizer incorporated into the fuel grain has an exponential effect on the burn rate - a relationship that was not previously considered. When an airflow was introduced to the 1:2 mixture, it ultimately extinguished the flame which was already weak to begin with. This was likely due to the low combustion temperature of the weakly oxidized mixture, which would have been lowered even further by the increased airflow. Because of this drastic difference between the 1:1 mixture burn rate and the 1:2 mixture burn rate, a third mixture was introduced into the experiment. The 2:3 mixture would have an oxidizer amount halfway between the two previous mixtures, and presumably an intermediate burn rate. As expected, when the 2:3, no airflow variable was tested it had an intermediate burn rate of 0.072 g/s, however, when the 2:3, airflow variable was tested, the burn rate decreased by a fair margin, as in the 1:2, airflow test, though not extinguishing

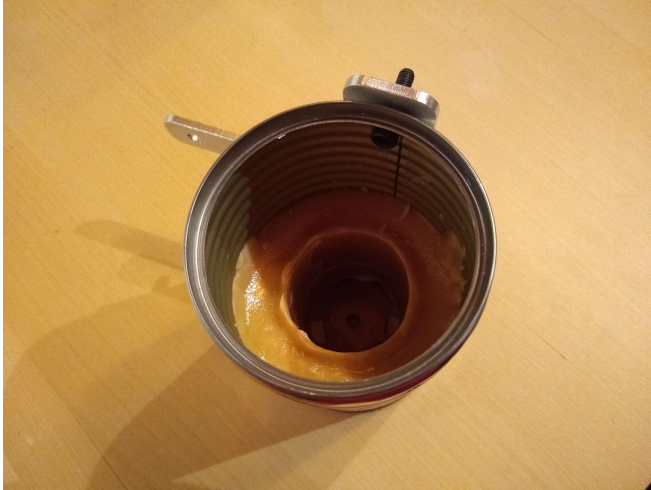
Figure 5.

Solidified fuel grain after removal of paper mold.

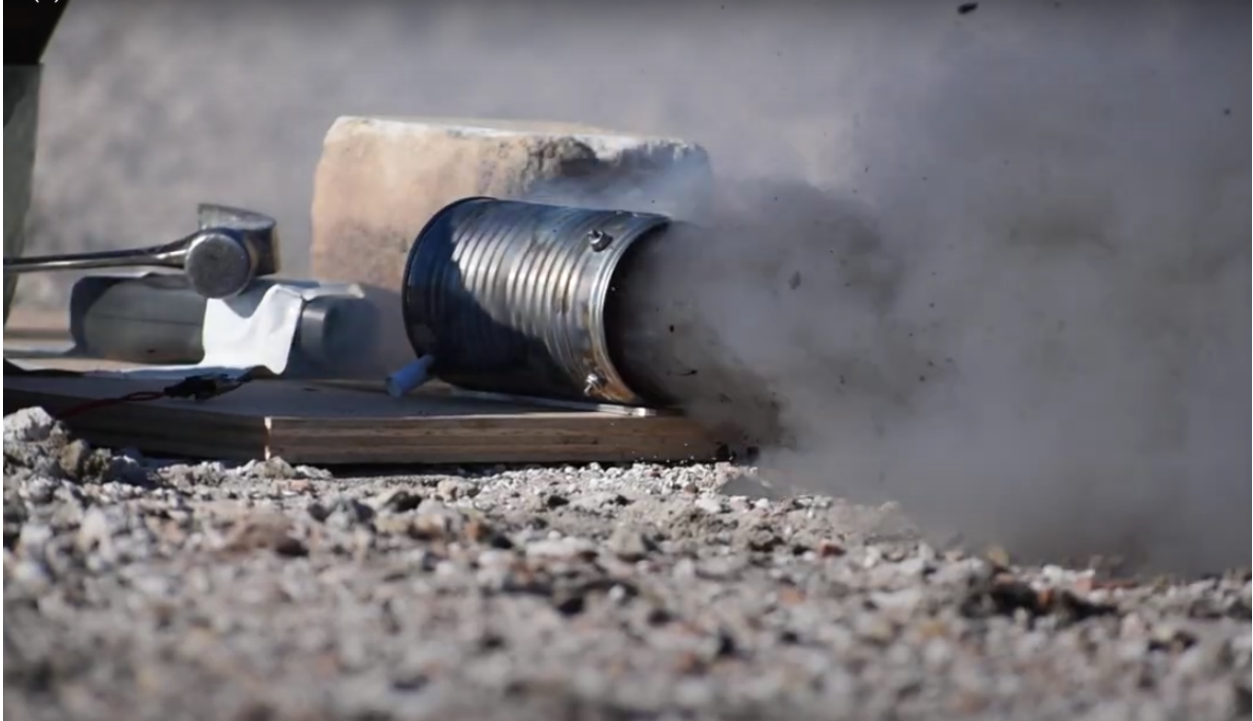
Figure 9.

Debris being ejected from the engine soon after turboshaft dislocation.

The last recorded value of angular acceleration was 2,690 RPM/s (282 Rad/s^2) before movement of the turboshaft was violently interrupted. This sudden disturbance resulted in the turbine angular velocity dropping from 6,300 RPM to 1,800 RPM in just 0.2 seconds, which is also represented in table 2 and fig. 8. At the same time, the mounting bracket for the engine could be seen to lift approximately 2 mm off the base before slamming back into place, slightly disrupting the phone camera's positioning with the jolt. Additionally, several very large pieces of what were likely combustion deposits being ejected from the engine at high speeds can be seen in the telephoto footage. (fig. 9) Soon after the rapid deceleration of the turboshaft, the exterior

fasteners connected to the bearing struts could be seen separating from the engine casing and rattling in place, indicating that the J-B Weld had failed, possibly in multiple areas. 4.67 seconds later, the rattling ceased, coinciding with a visible change in the exhaust smoke pattern, which began rotating counter-clockwise as seen from behind. Finally, the exhaust velocity slowed, eventually concluding fuel grain combustion at $T + 17.74$ seconds. This meant the majority of the fuel grain was consumed in a time interval of 13.64 seconds. As the exhaust gasses dispersed, the throat of the engine produced a small orange flame. This was caused by an unintentional ignition of the polymer-based J-B Weld, and was soon extinguished when the engine was approached and doused with a bucket of water. Other than this, no additional instances of unintentional fires occurred during the test. When collecting the recording instruments, it was found that both the phone and telephoto camera had successfully captured their respective footage and were powered off. This concluded the test of Prototype 1.

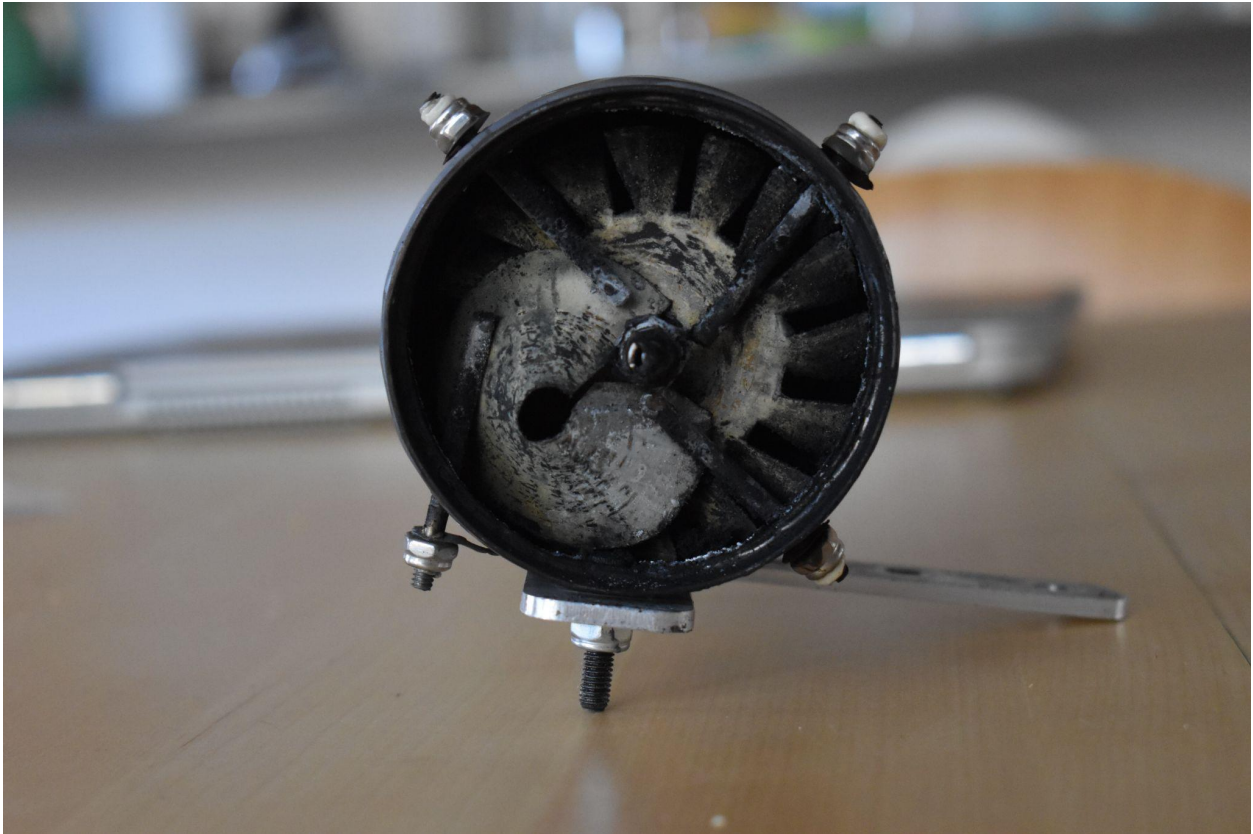
Figure 10.

Shown in fig. 10, the displacement of the turbine is extremely visible as well as the separation of the aft cone. This clearly indicates that the J-B Weld failed, as anticipated. In addition to the turboshaft structures separating from each other, the entire turboshaft became dismounted from the bearing struts with the reflector disk pressing into the front exterior of the engine. The reflector disk, itself, had been superficially damaged to the point where it would not be able to serve its intended purpose. The reflective tape strip had fallen off and the black paint had been weakened so that large sections flaked away, though the overall structural integrity of the disk had not been compromised.

Photograph depicting the interior of Prototype 1 following testing.

When the engine parts were removed for a more in-depth analysis of their condition, it was found that the turbine blades had been slightly angled in a counter-clockwise direction, though they were relatively undamaged. This can also be seen in fig. 10, along with circular scratches on both the turboshaft cone and turbine. There was almost no remnant of J-B Weld adhesion on the interior of the engine where it was used copiously, with the only exception being joints between the turboshaft and bearings. However, there was a significant accumulation of carbon deposits inside the engine casing and on the turbine blades, with the layer being as thick as 1 cm in some areas. The only components that were spared from the deposits faced aftward of

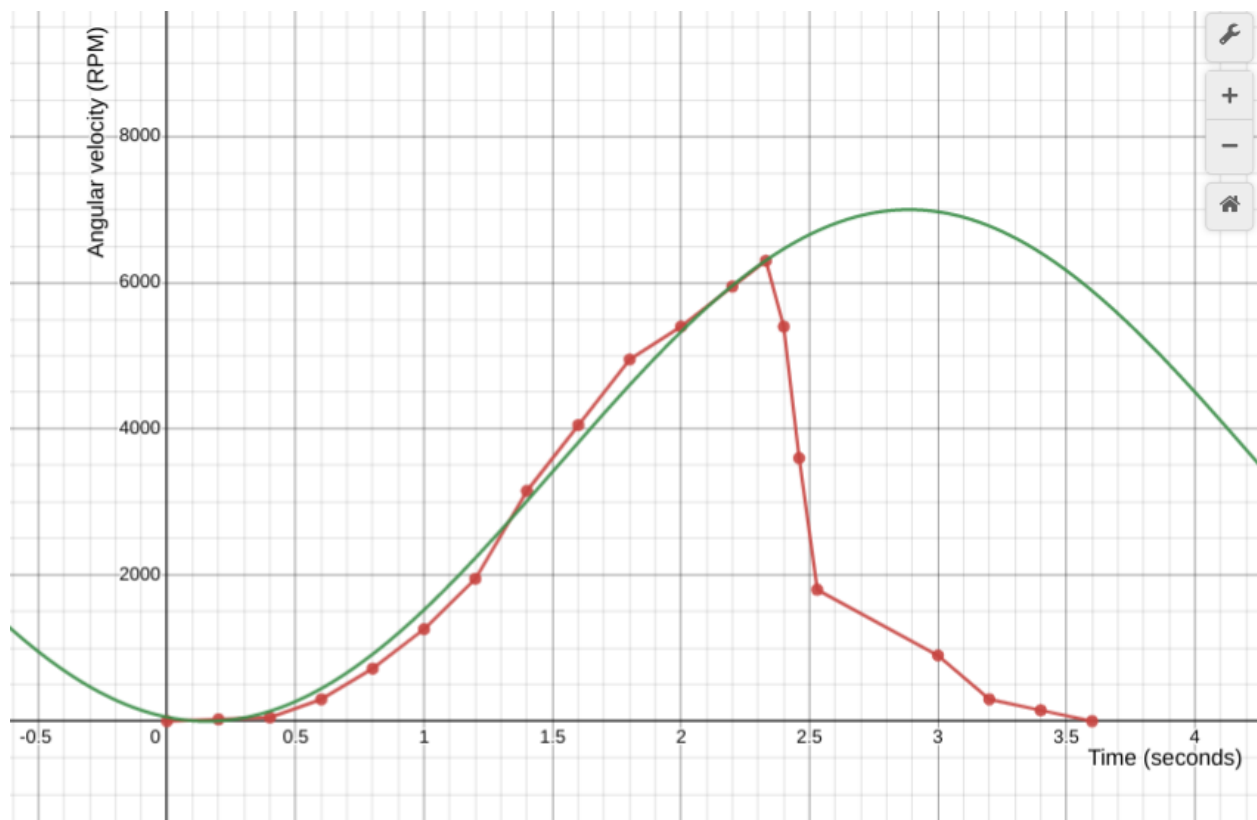
Figure 11.

As shown in fig. 11, the vertex of the equation lies at the coordinates (2.89, 7000). This indicated that the turboshaft of Prototype 1 would take 2.89 seconds to reach maximum angular velocity, which would be approximately 7,000 RPM. This estimated angular velocity is not quite as much as the benchmark of 12,000 RPM, which raised some concerns. Though the benchmark was initially designated as a threshold of feasibility, it also was formulated using very rough approximations. Additionally, the turboshaft's maximum angular velocity cannot be completely determined until a second prototype has been tested. While this estimated maximum angular velocity was slightly lower than the specified requirement, the approximate time to reach that velocity would exceed expectations, at 2.89 seconds. In this duration, only 21% of the fuel would be consumed, reserving the rest for efficient oxygenated combustion.

Turboshaft angular velocity graphed with corresponding trigonometric equation.
